# Dahl Memorial Medical Clinic

## Alaska Rural Primary Care Facility

### Assessment and Inventory Report

**November 12, 2002**

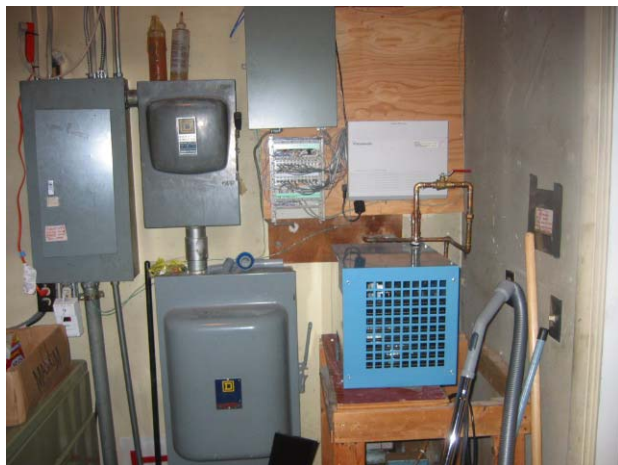
**AGE30**  
**Laundry/Electrical**

a. Overall Space Deficiencies: The Skagway clinic exceeds ARPCF space requirements by approximately 1623 SF; however, the facility is deficient in office space and lacks arctic entries. The laundry room, although not included in program requirements, is too small, blocking electrical panels and needs to be expanded.
